The Major Problems

Volume and Velocity Engineering Problem

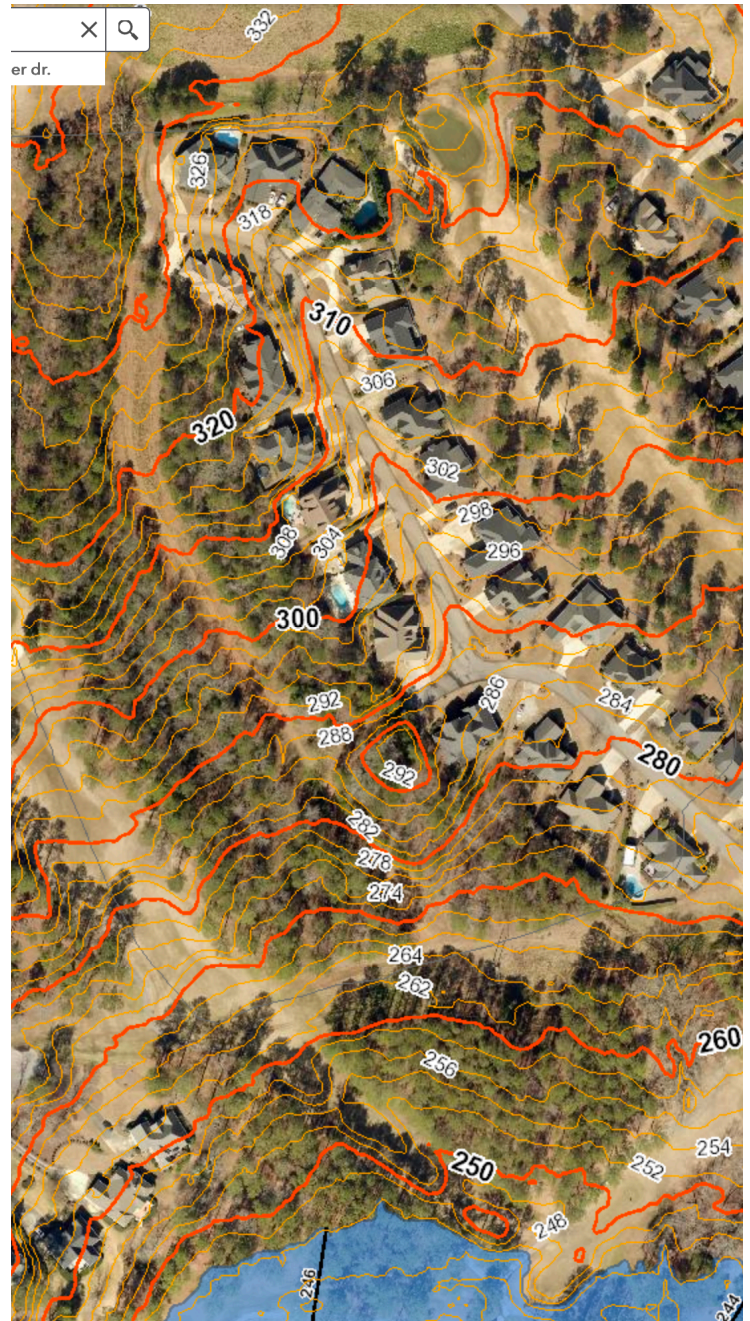
- Volume
 - A dirt road base run of over 1050 feet, and about 50' wide,
 - This equals 52,500 sq. ft. of unprotected dirt, which is over 1.2 acres,
 - On top of this the area, the sides of the road contain another 10 feet, or so, of mixed dirt and disturbed ground,
 - All of these areas are funneled into a lower roadbed, to create a flume for silt headed to a cul-de-sac area.
- Velocity
 - All of this water volume is being pulled down by gravity by a 1050 foot run sloping down 68 feet in elevation. This is a slope of about 1 foot drop for every 15.4 feet.

All of this Volume and Velocity is being met by one cul-de-sac area that is supposed to be designed to stop 80%, or more, of the silt carried by the watershed. After two tries there has not been a success yet, I don't know if it is possible with the Volume and Velocity problem.

THE FUNNEL TO DIRECT ALL SILT TO THE POND

- "Segment the site into manageable sediment storage areas for using multiple silt fence runs. The drainage area above any fence should usually not exceed a quarter of an acre."¹ This indicates that the flow down the hill should have required at least four control segments to slow the flow of water and sediment before hitting the final area in the cul-de-sac area.

- "Water flowing around the ends of a silt fence will cause additional erosion and defeat its purpose. The bottom of each end of the fence should be higher than the top of the middle of the fence. This insures that during an unusually heavy rain, water will flow over the top rather than around either end of the fence. Only fine suspended material will spill over the top, which is not as harmful as having erosion at the ends."¹ Most of the sediment fences I have seen have water flowing around the ends and do not have the ends elevated over the middle.
