# Main Input Ditch

## A Volume, Velocity, Maintenance, and Design-Build Problem

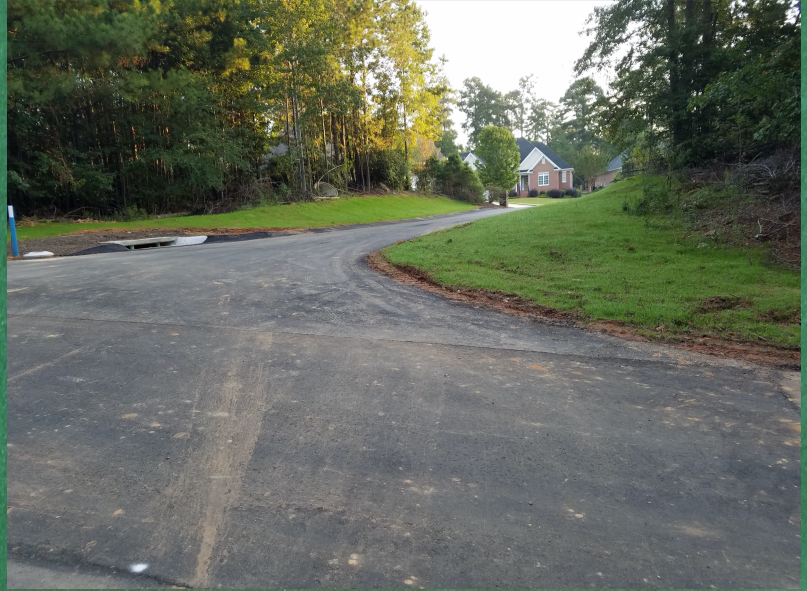
Anyone who has viewed the new Golden Hills home development site since December 2020 can clearly see there has been a big improvement in sediment control. All of the pavement is completed, storm drains are properly installed, grass has covered about all of the unstable areas, and more.

This is great news, but there is another stage coming to our silt problem - with the development of around 50 new homes, this will reopen acres of soil that will be loose and ready for erosion.

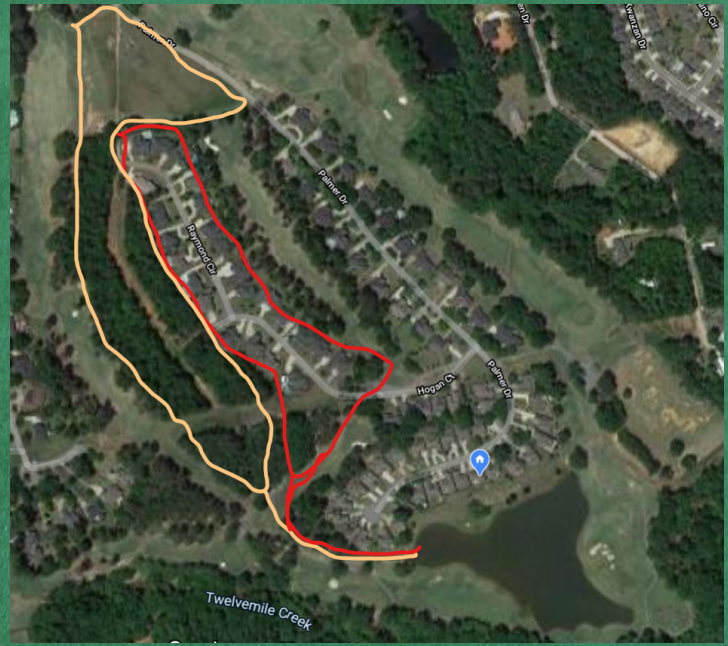
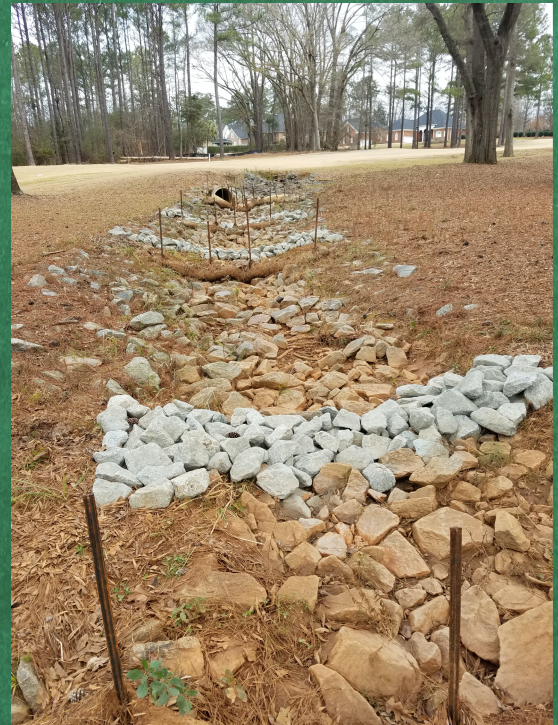
#3 **Design, Build, and Maintenance:** All of the water coming at a high velocity hits a single ditch that is undersized and poorly designed for volume, velocity, and silt control.

It does not require an engineer to look at this ditch to reasonably know that it will not be able to handle a half-inch of rain over an hour, or less, where up to 271,524 gallons of water comes into this ditch within a period of time of about an hour and one half. This is enough water to fill just short of thirty 21 foot wide by 4 foot deep pools. Which is

also around 3,016 gallons of water per minute, which is enough water to overflow a 12 foot wide by 4 foot deep pool every minute. Again, it does not require an engineer to know that this ditch in its present condition will generally not stop 80% of the silt required by DHEC stormwater regulations for anything other than small amounts of rain.

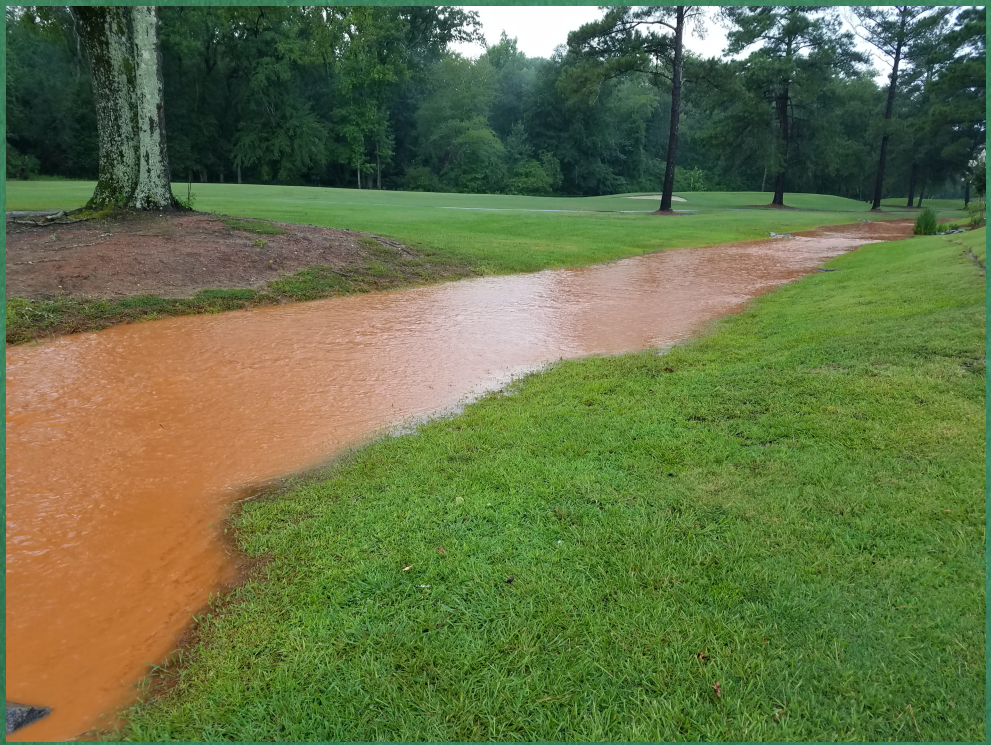
#4 **System Note:** I am told that this problem was recognized by DHEC a few years ago. In response to silting problems experienced with the build of Raymond Circle development area of Golden Hills, they required the ditch that runs along the #6 fairway to be a silt catch basin. It is hard to tell today, but there were rock silt check dams

installed about every thirty feet or so to catch the silt. The areas between these dams were maybe 2 to 3 feet deep to catch the silt. However, as outlined in DHEC's silt educational material, **the best management practices part of any silt control feature is "required regular maintenance"**. When these voids between the dams are filled with silt, that silt has to be maintained by digging the accumulated silt out and carried to an area not affected by erosion. When looking at this ditch today, you will find it difficult to surmise if this area was ever a ditch. Presently you can only see some of the tops of the rock silt dams.

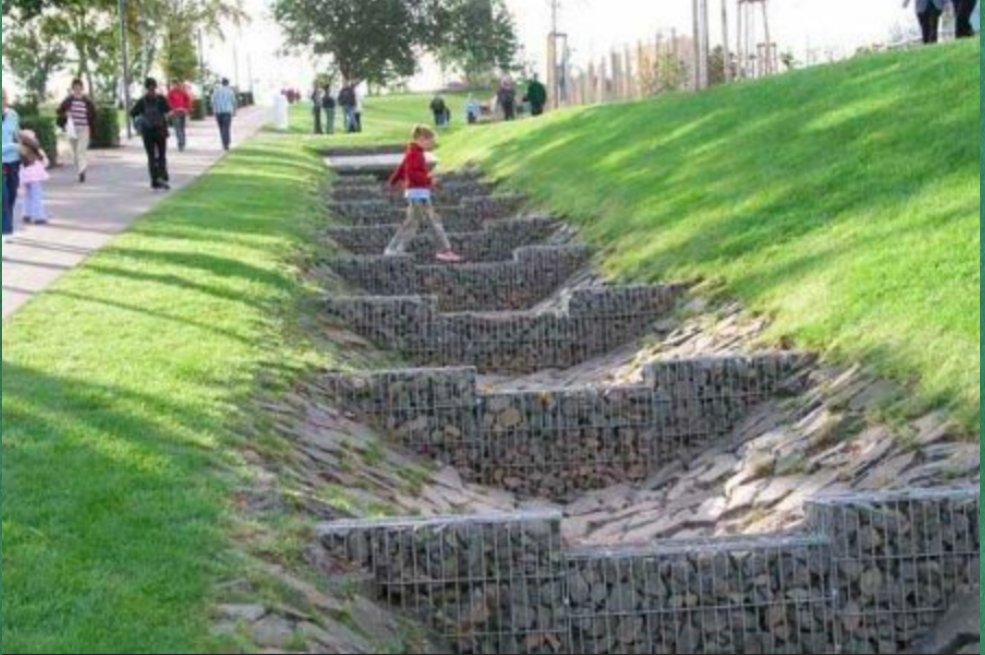
**How The Dams Work:** In the picture to the right, you can see how the check dams are elevated but have a lower area in the middle of the dam to allow the water to flow over the top easily. As the water flows down, some amount of silt is caught behind each dam,

and whatever silt gets through or over the first dam has to continue through or over the others. This entire process slows down the water flow and filters out 80% or more of the silt as it flows through all dams.

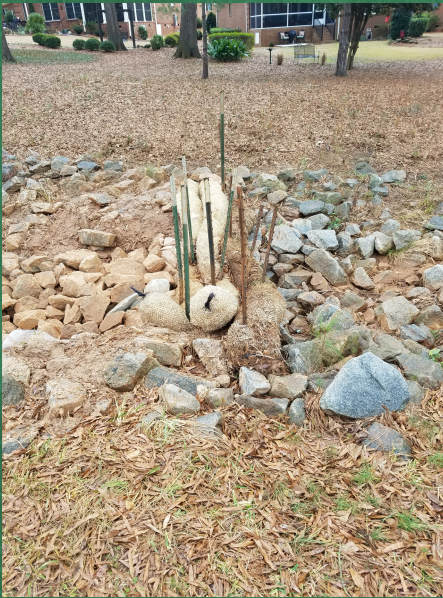
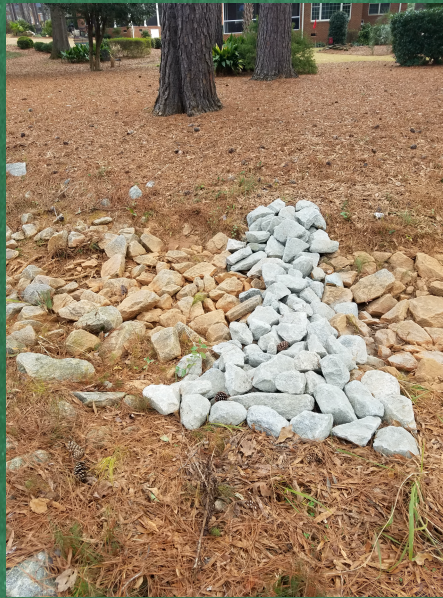
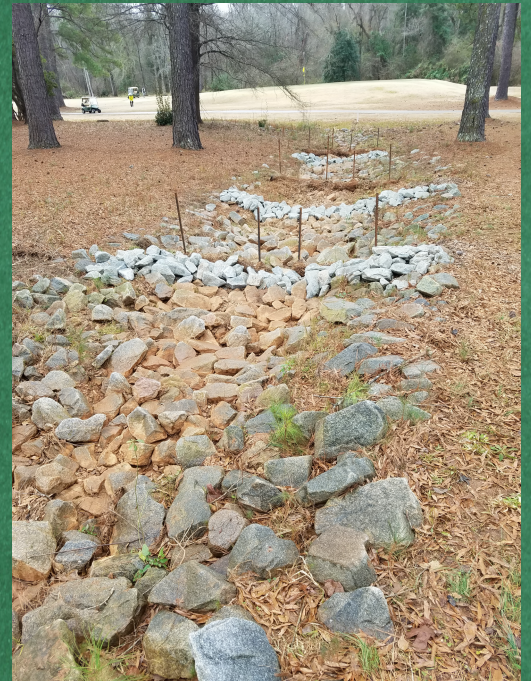
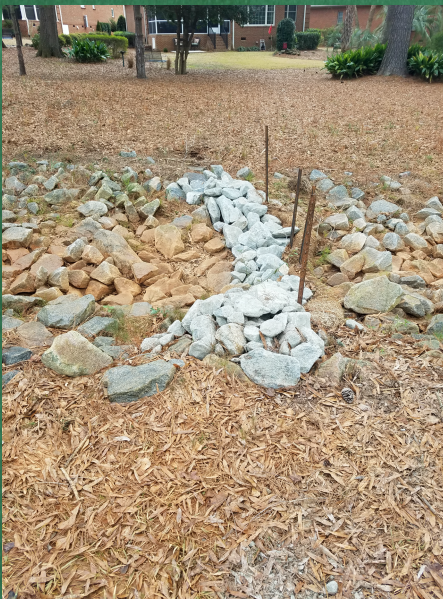
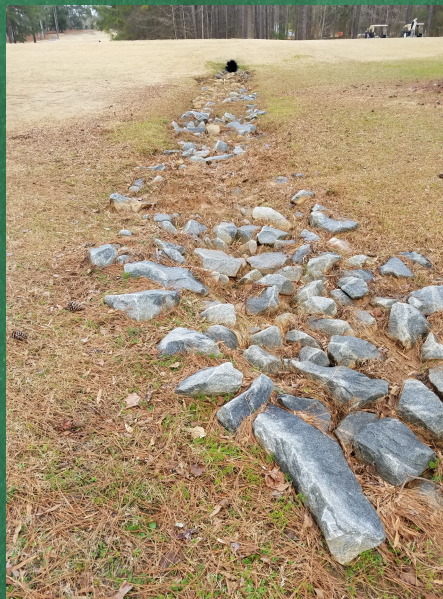
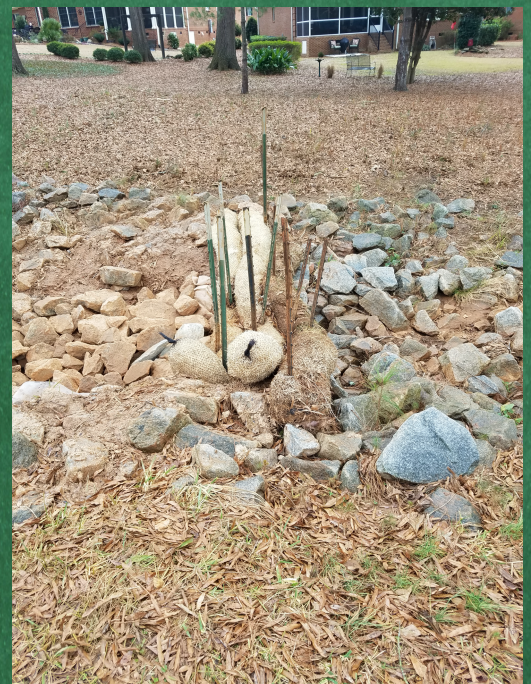
These pictures are of an attempted silt rock check dam for this project. We believe this an insufficient attempt for the volume and velocity of water on this site. Some areas of concern include:

- \* Rock Check Dams not built to DHEC BMP's
- \* Insufficient sediment collection areas
- \* The use of sediment tubes here and the poor installation of them
- \* And more...
